CRASH INJURY BULLETIN

**MODIFICATIONS TO THE PASSENGER SEAT-BELT
TIEDOWN ATTACHMENTS IN THE**

U.S. ARMY HU-1 SERIES BELL IROQUOIS HELICOPTER

TCREC Technical Report 62-45

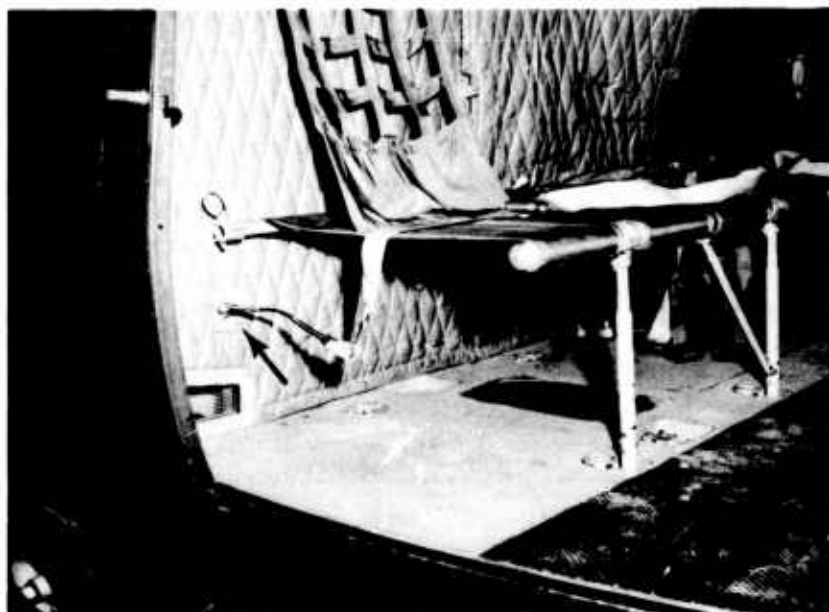
Figure 2. Typical Seat-Belt Tiedown Installation in the HU-1 Helicopter.

A review of several HU-1 helicopter accidents* reveals that failure of the passenger seat-belt tiedown occurs at the casting where the cable clevis is attached.

Figure 2 illustrates the tiedown installation as presently installed in HU-1 helicopters.

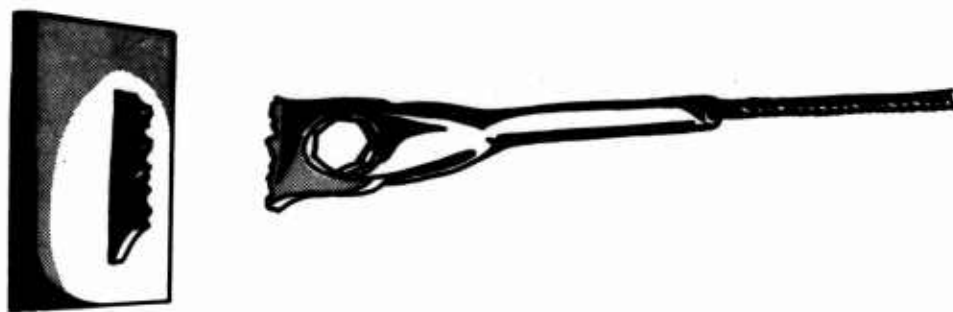
Figure 3. Typical Failure of the Seat-Belt Tiedown Casting.

Figure 3 illustrates a typical failure of the aluminum seat-belt tiedown casting. The rigidity of the system is obvious.

Note that lateral movement is not possible at the point where the fork-end is attached to the casting. Excessive bending stresses at the attachment flange of the seat-belt tiedown bracket can be produced by side loads transmitted through the seat belt.

Only 1 degree of freedom (vertical) is available with this attachment system. Spot checks of several HU-1A helicopters revealed that the fork-end cable terminals were tightened on the casting so tight that the vertical freedom was eliminated, resulting in a rigid connection from the cable to the casting.

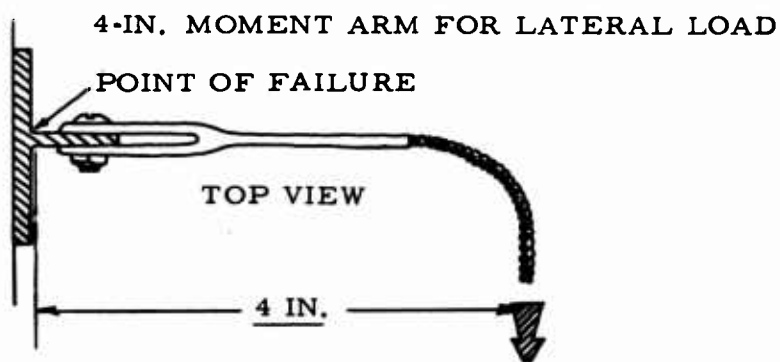
Figure 4. Present Tiedown Configuration.

The present cable attachment provides a moment arm of approximately 4 inches when side loads are applied as shown in Figure 4. With this moment arm, only 800 inch-pounds (4 inches x 200 pounds) of direct side moment are required to break the attachment casting.

The 4-inch moment arm could be reduced to 1 inch if two "off-the-shelf" cable shackles were installed between the end of the cable terminal and the tiedown bracket, as illustrated in Figures 4 and 5.
